Photo Report of Koteles Garage

Site Inspection Date: 06/10/2020

Inspector: Nathan Marcus, E.I.T.

Prepared for: Levandosky v. Koteles Dispute

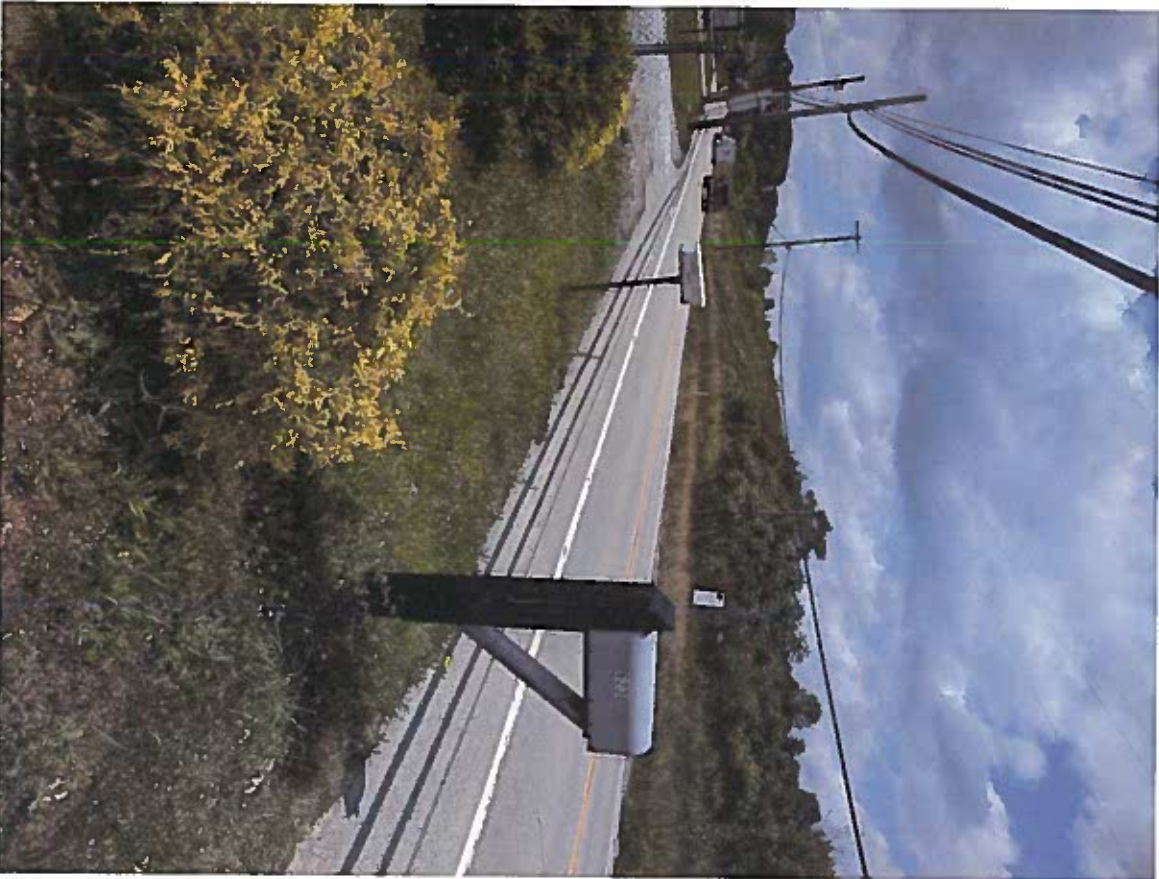
Mailbox with street address of property. Mismatched unpainted wood holding it up.

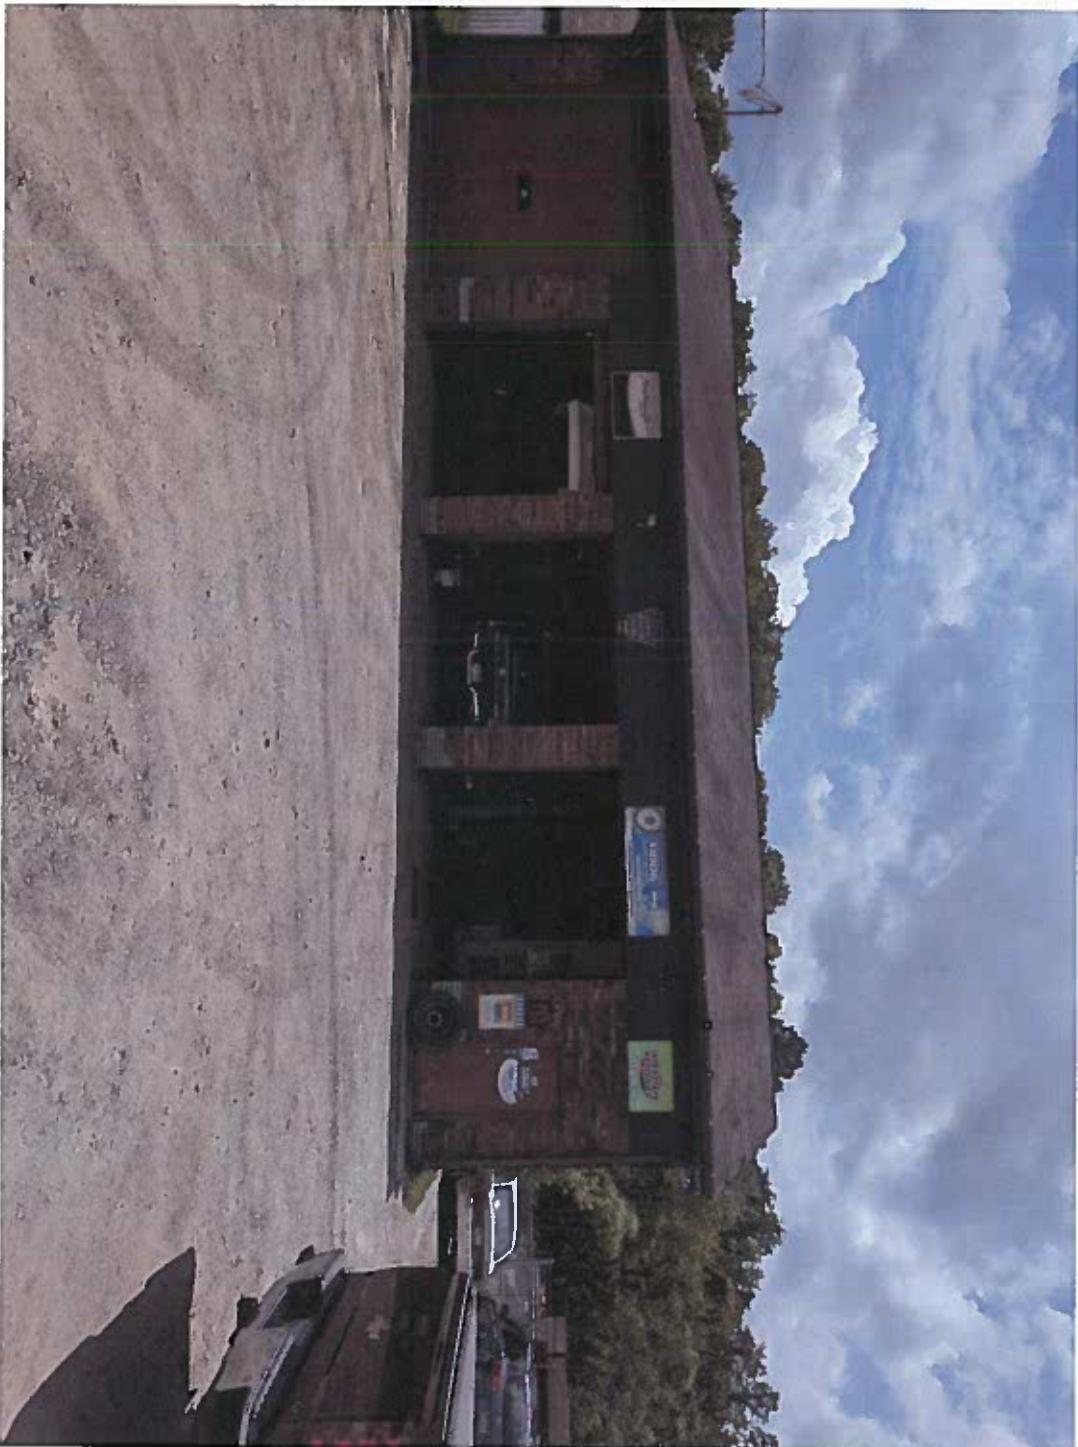
Overall view of the front of the property. Lot is unpaved. The gravel is thin. Parking spots are unpainted. Exterior lights were not confirmed to be operational during the site visit.

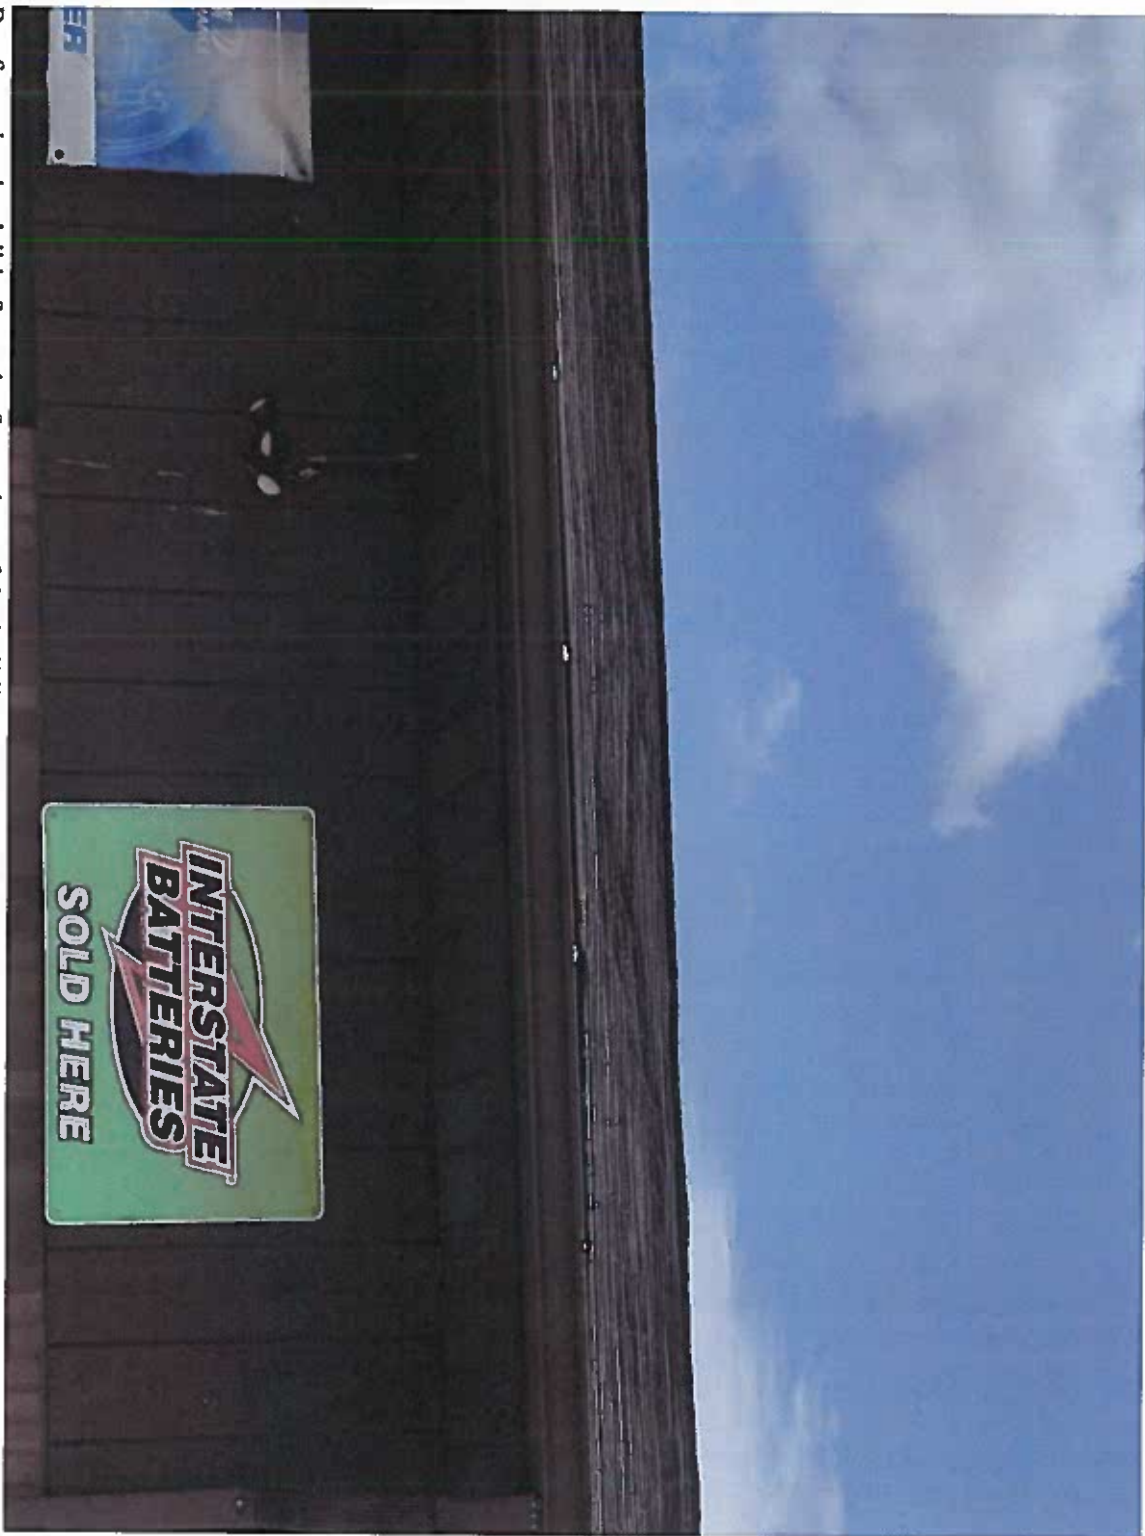
Roof sagging is visible from the front view of the building's roof shingles.

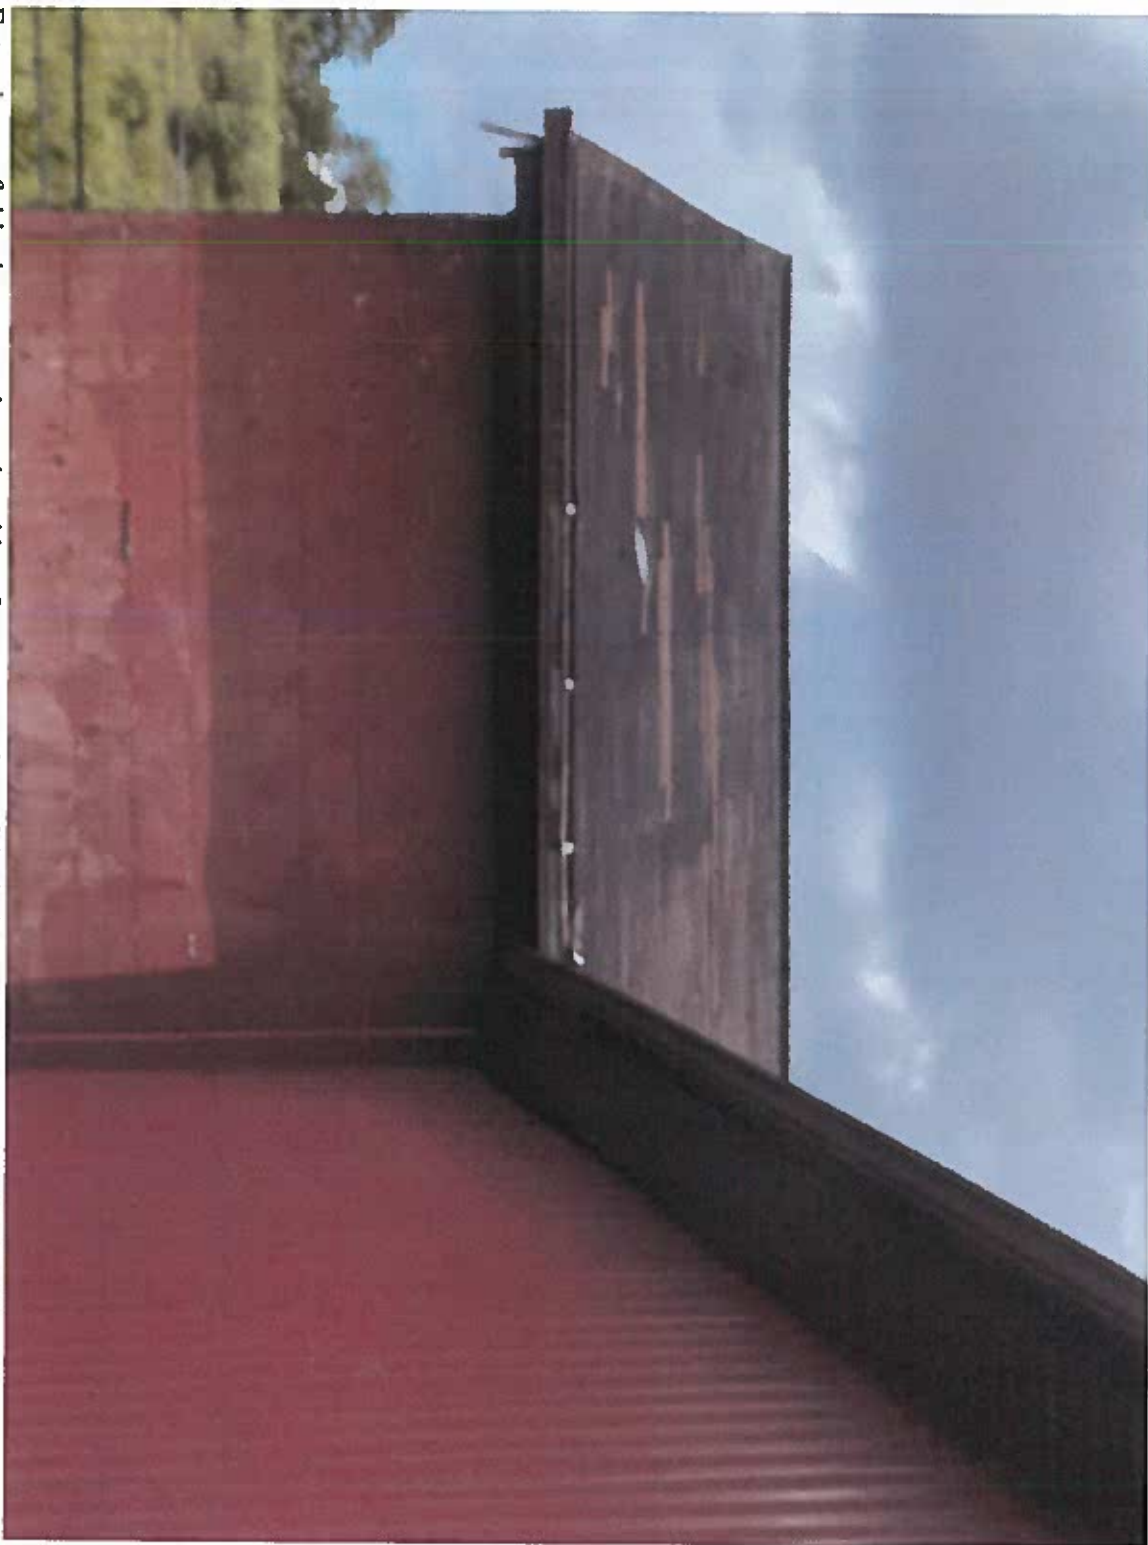
Extensive roof shingle wear and tear is evident from a rear view of the building facing towards PA SR-88

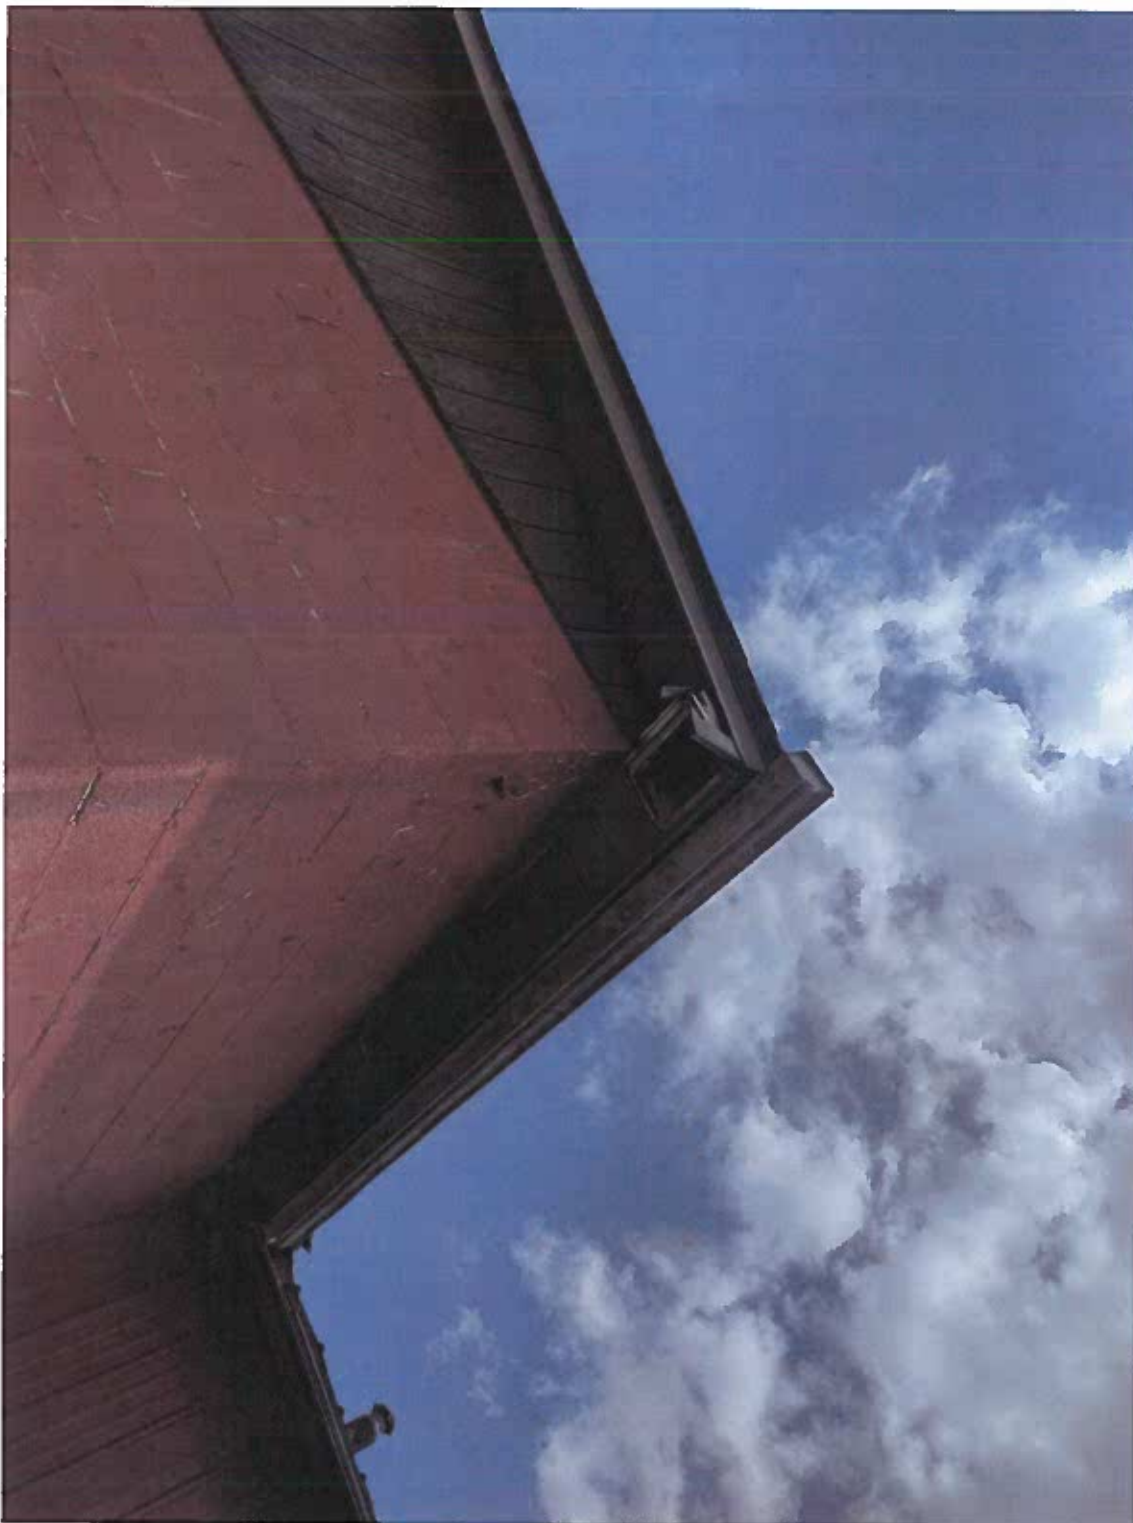
Unrepaired damage at the lower corner of the roof.

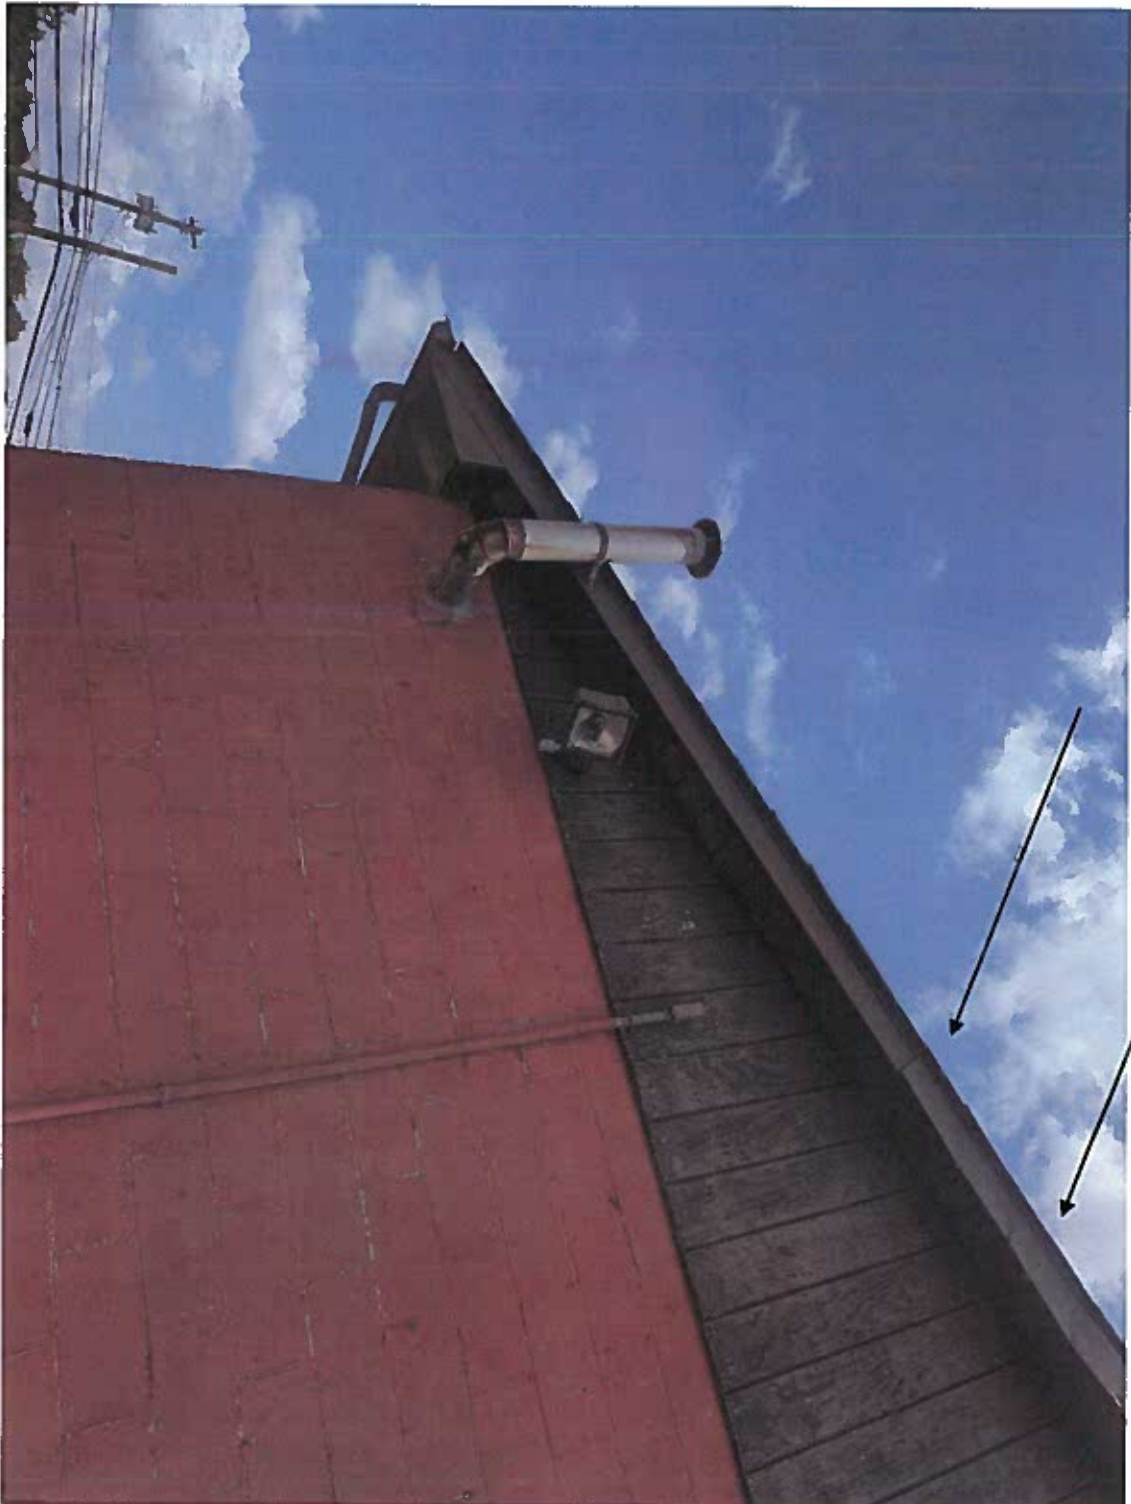
Brown flashing is pulling away from the roof line

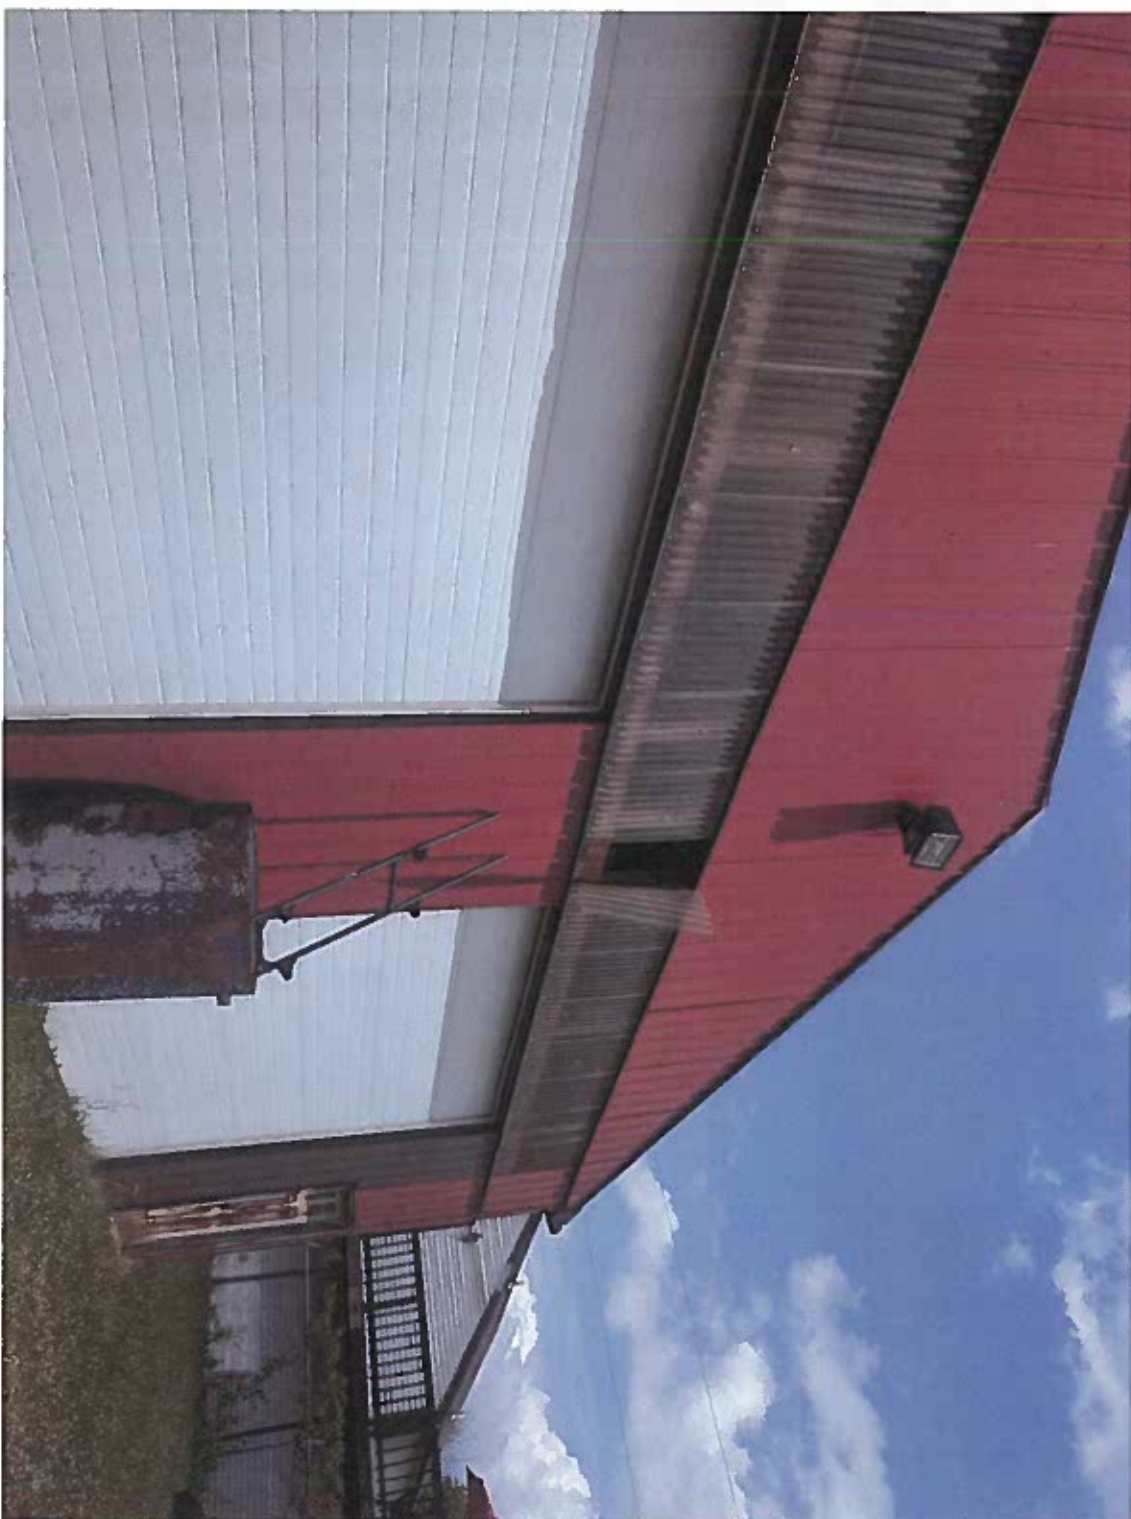
Trim pulling away from the building. External light above the trim was not confirmed to be operational.

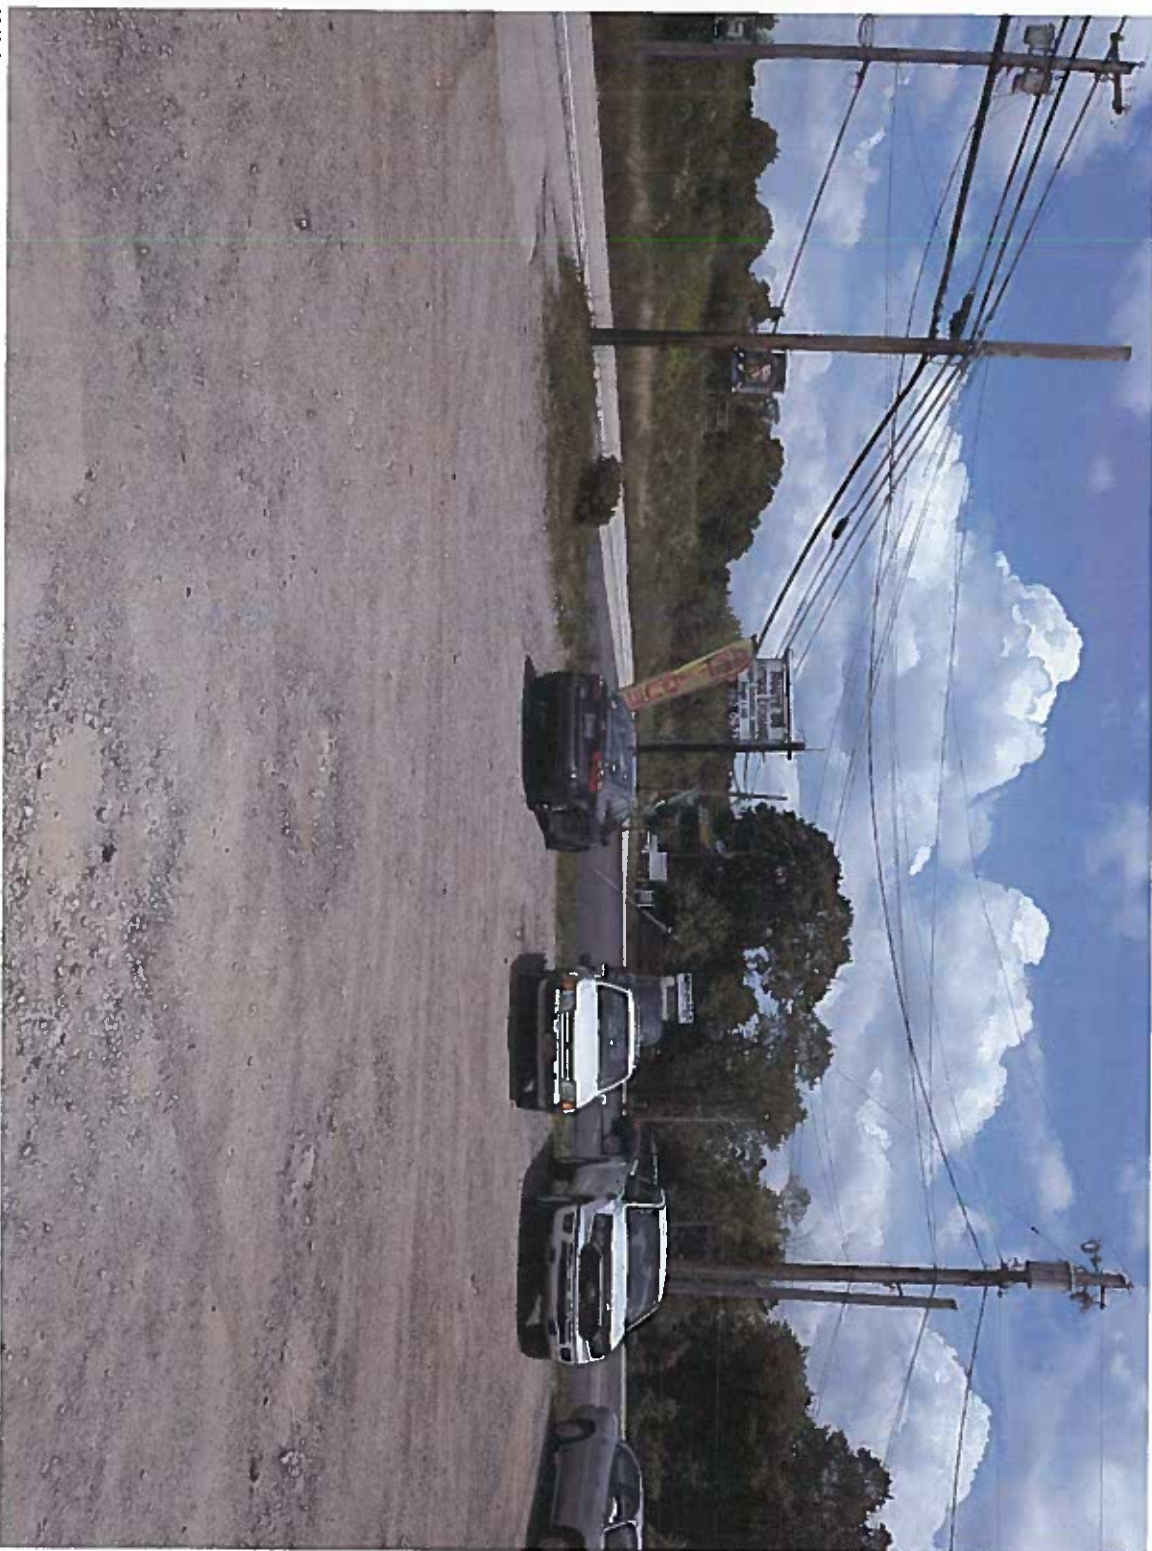
Wide overview of front lot. Note the holes, ruts, and defects in the parking lot.

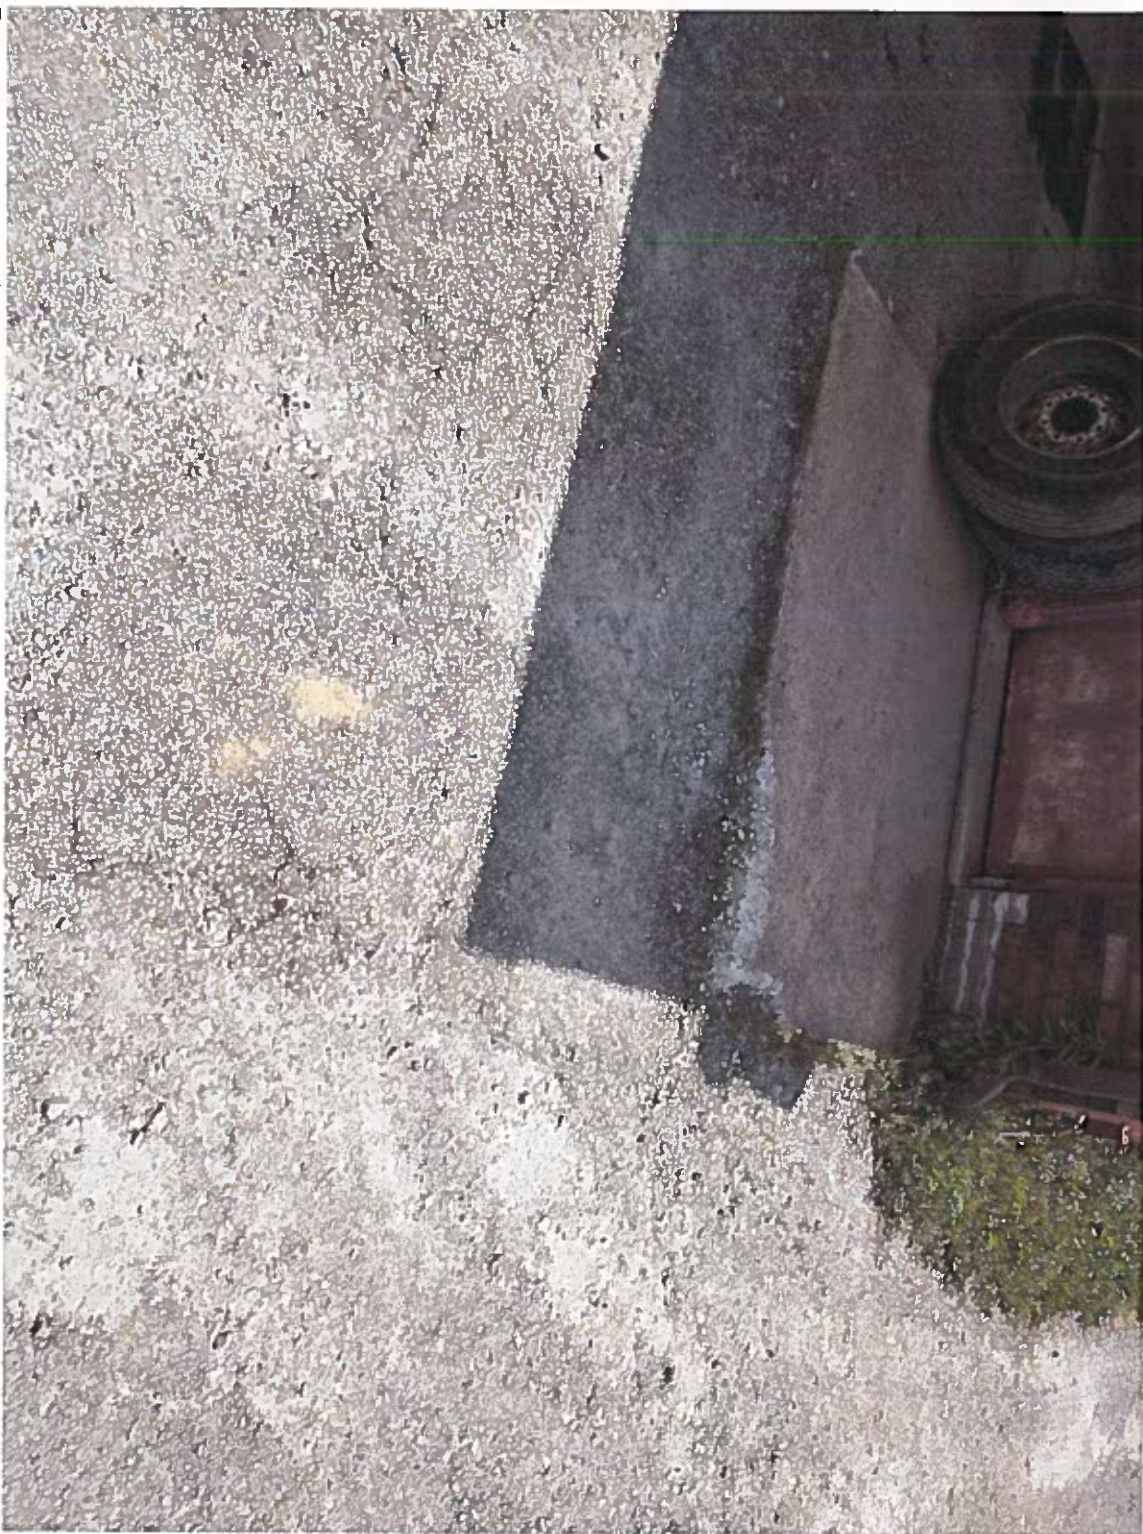
Damage to cement pad near front door.

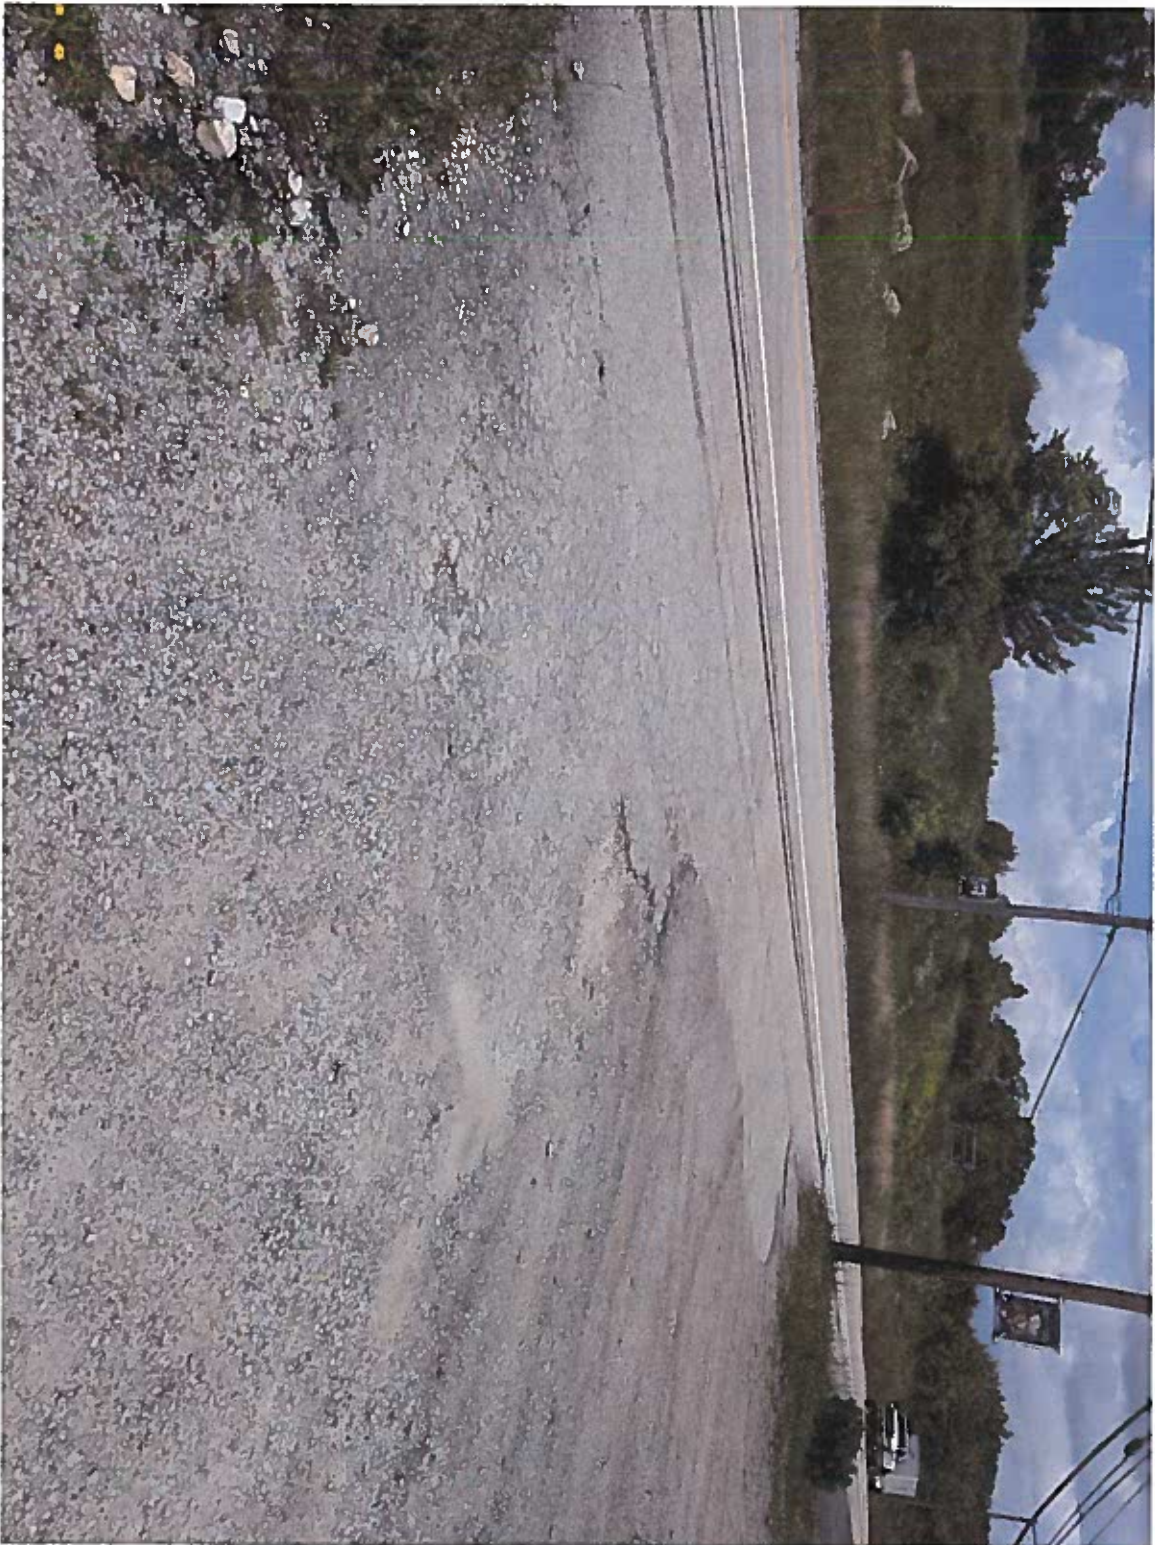
Cracking pavement near the access transition between SR-88 and Koteles Garage

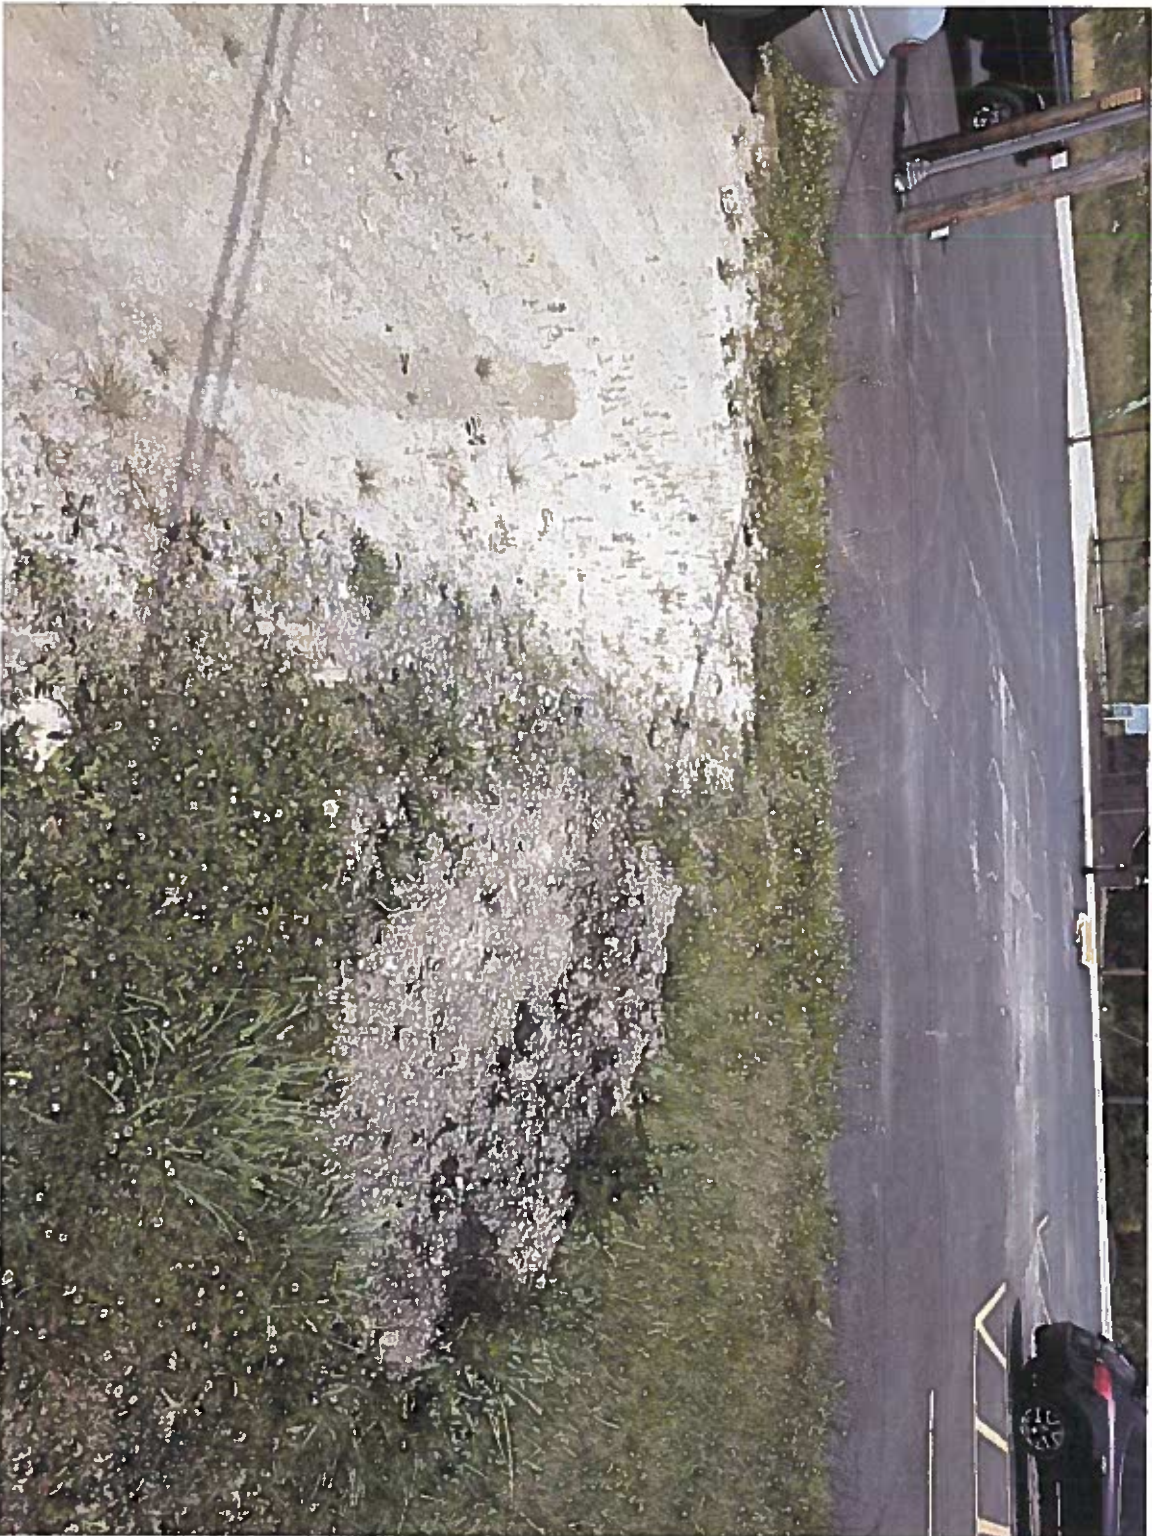
Loose pile of gravel near front parking spot. Note how thin the parking lot gravel is.

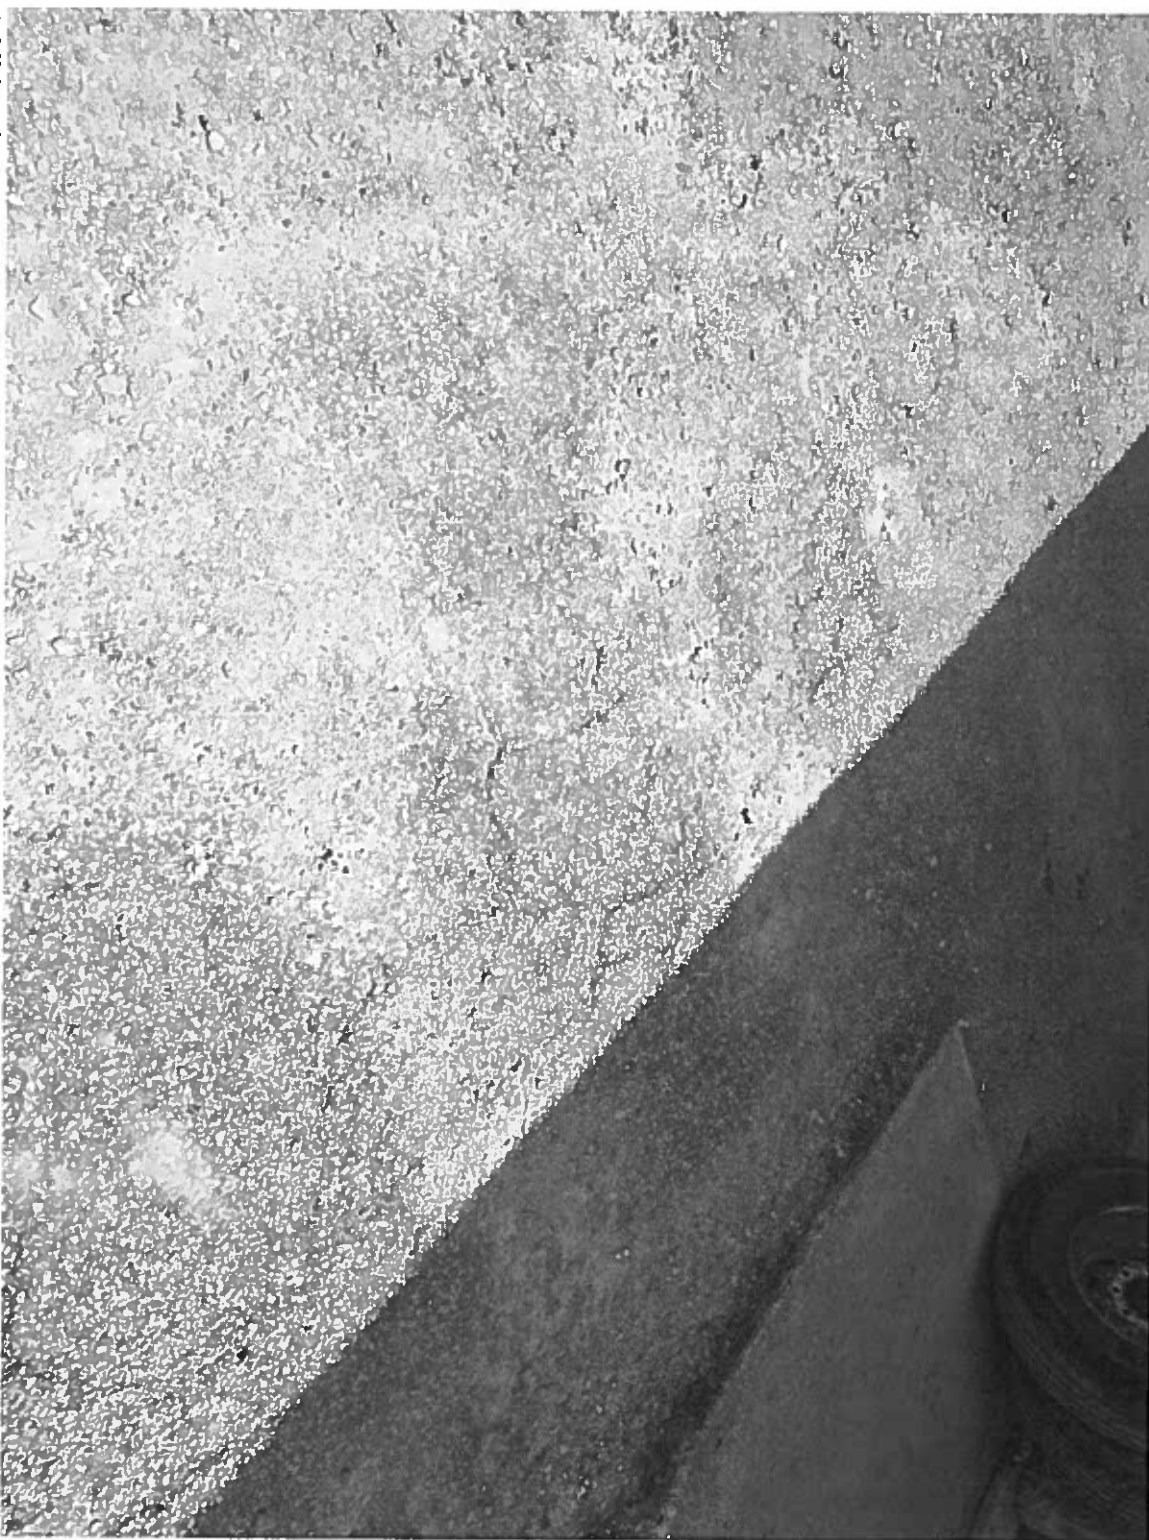
Additional cracking in the front parking lot.

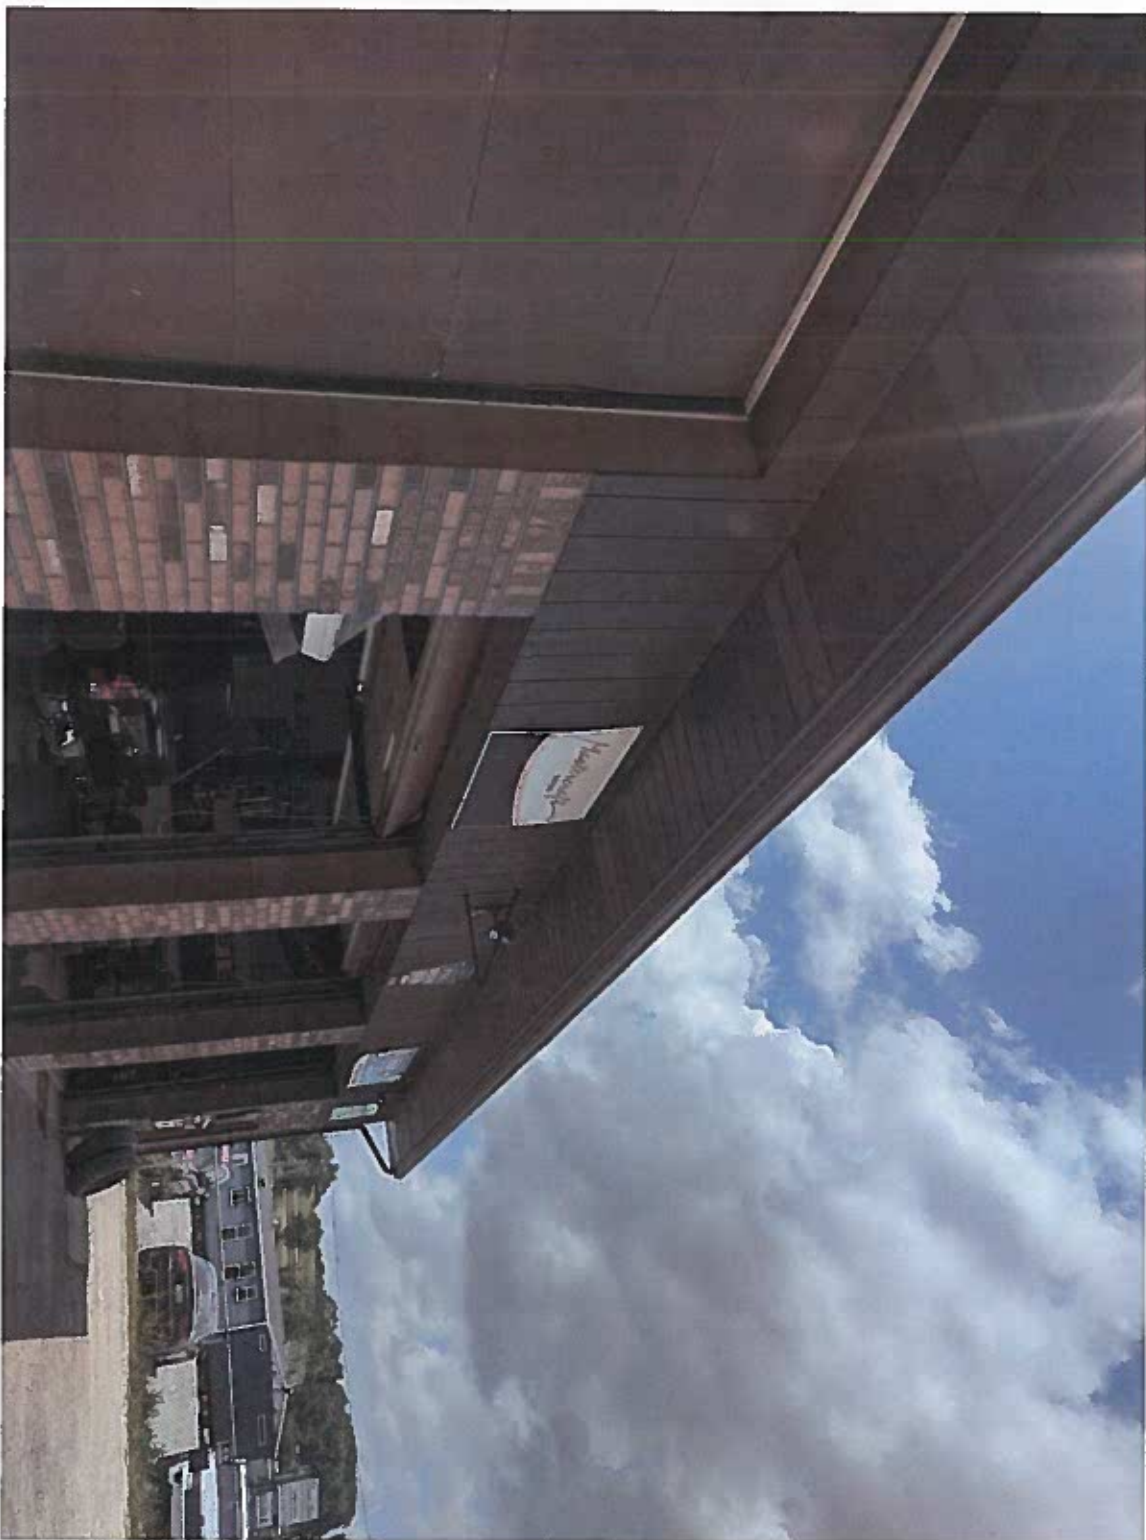
Overall view of front garage bays. Some damage at lower portions of brick pillars can be seen.
